**INVESTIGATION OF EMPTY WOODEN AMMUNITION
BOXES FOR PROTECTIVE CONSTRUCTION**

October 1971

NAVAL CIVIL ENGINEERING LABORATORY

Technical Report R-738

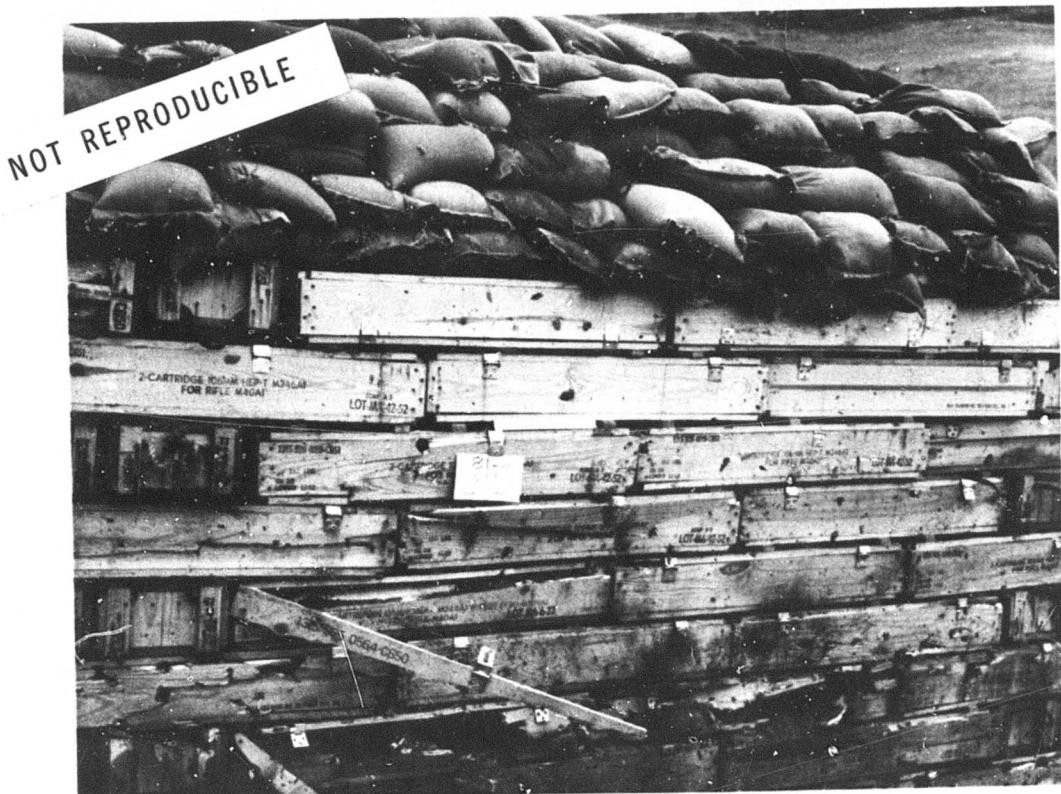
The 2 feet of box wall thickness provides complete protection from the fragments of an 81-mm mortar at any separation distance. Complete protection from a 105-mm artillery round requires a separation distance of at least 18 feet; while complete protection from a 155-mm artillery round requires a separation distance of at least 25 feet. Collapse of the bunker can be expected to occur at a separation distance of about 4 feet from a 105-mm round and about 9 feet from a 155-mm round. Figures F-7 and F-8 are typical photographs showing more severe damage.

Figure F-7. Damage from 81-mm round at 4 feet.

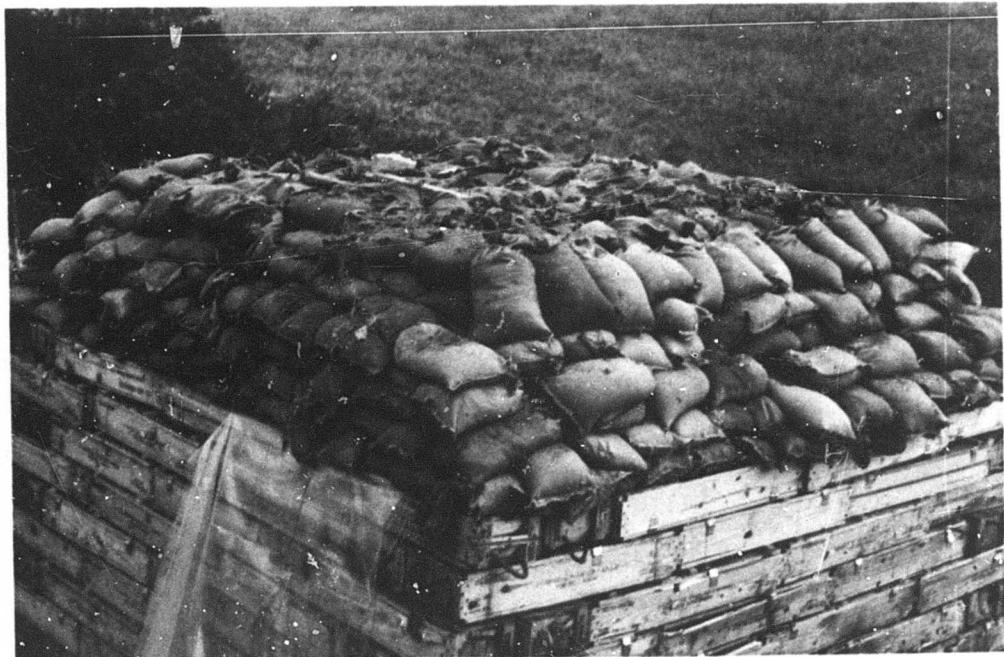
Two 81-mm mortar rounds were exploded on top of the bunker; one 2 feet above the overhead sandbags and the other in contact with the sandbags. In both cases no fragments penetrated into the bunker. The roof

suffered damage consisting mainly of destroyed sandbags (Figure F-9). The beams directly beneath the exploding rounds had a permanent deflection of about 1 inch for the 81-mm mortar round placed 2 feet away and 3 inches for the 81-mm mortar round placed in contact with the sandbags (Figure F-10).

Figure F-9. Damage from 81-mm round 2 feet above roof.

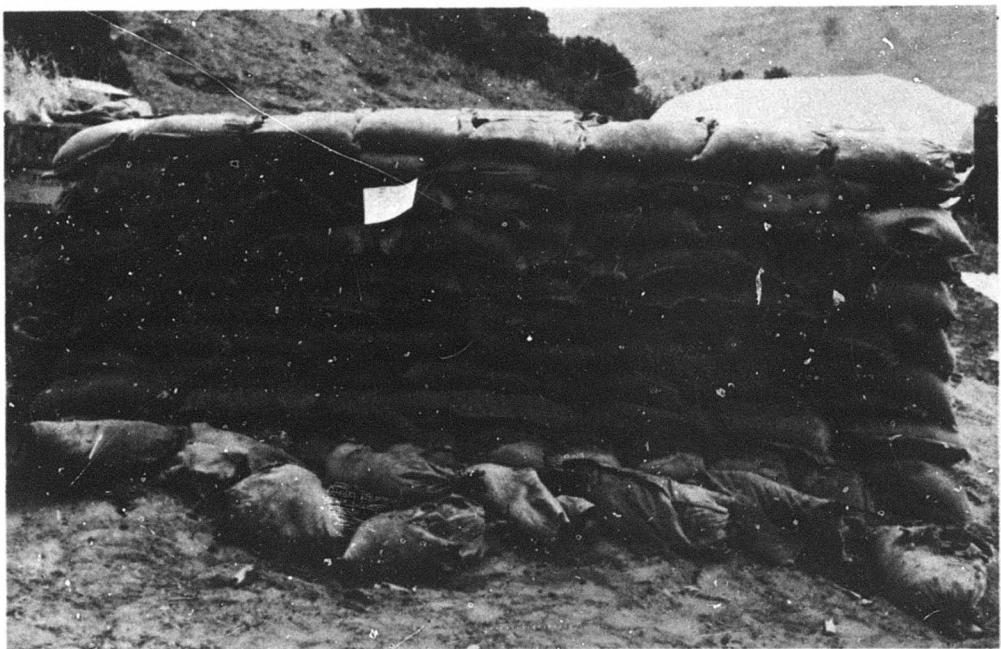
As noted in Table F-1, the sandbag walls appeared to be slightly more effective in stopping fragments than did the ammunition boxes. This is understandable, since a sandbag torn by a fragment tends to seal itself by the weight of soil above (Figure F-11), whereas a hole in a soil-filled ammunition box results in a loss of a portion of the soil through leakage. This fact is very significant when considering the protection required against direct fire from a 50-caliber machine gun. Although the amount

Figure F-11. Damage to sandbag wall from 81-mm mortar round at 10 feet.

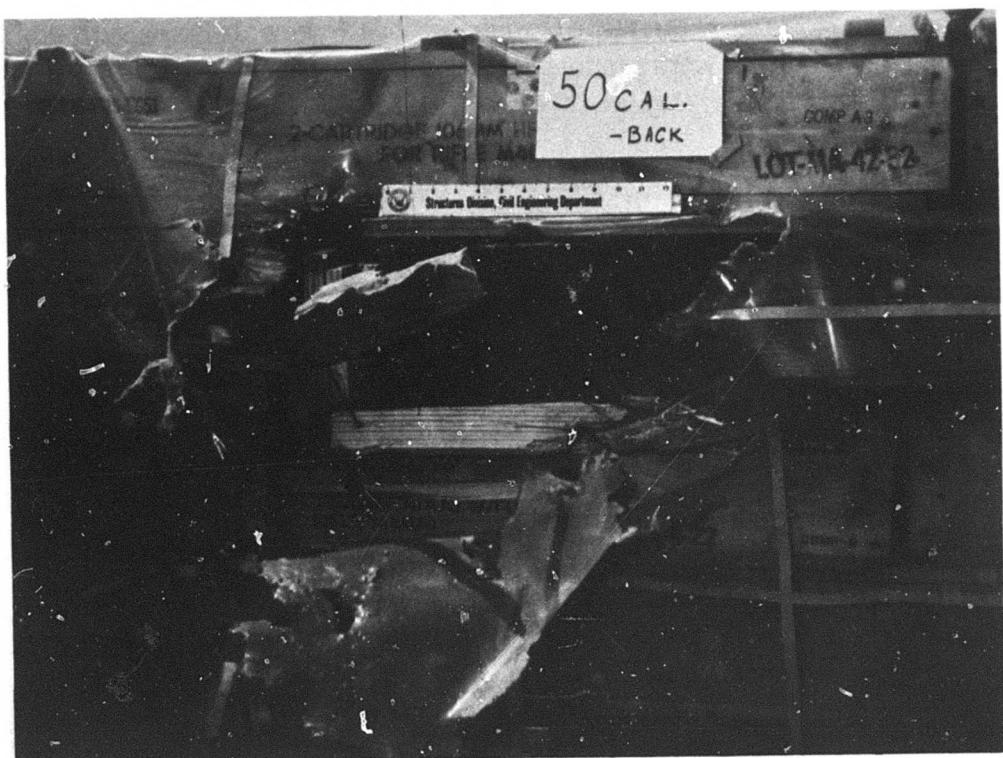
of soil present is sufficient to stop a single 50-caliber round, repeated fire causes a hole to form, resulting in loss of soil (Figures F-12 and F-13). Thus in effect the machine gun bores its way through the wall. This problem can be overcome by providing three layers of boxes in the exposed portion of the wall as described in the report.

Figure F-13. Damage to test wall (rear) from 50-caliber machine gun fire.
